Report of Sampling and Analysis Results

**Davisville Army Housing Units
North Kingstown, Rhode Island**

August 1990

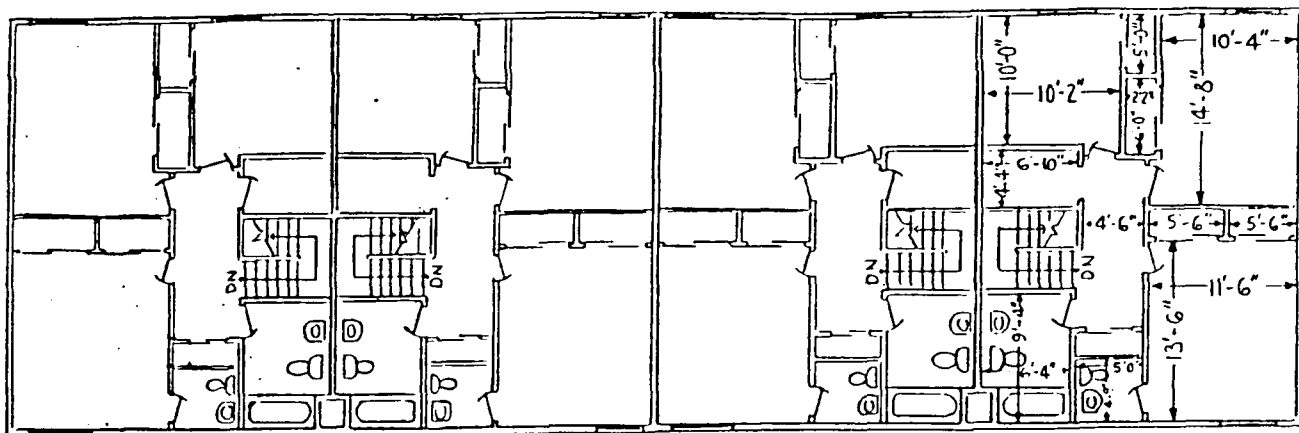
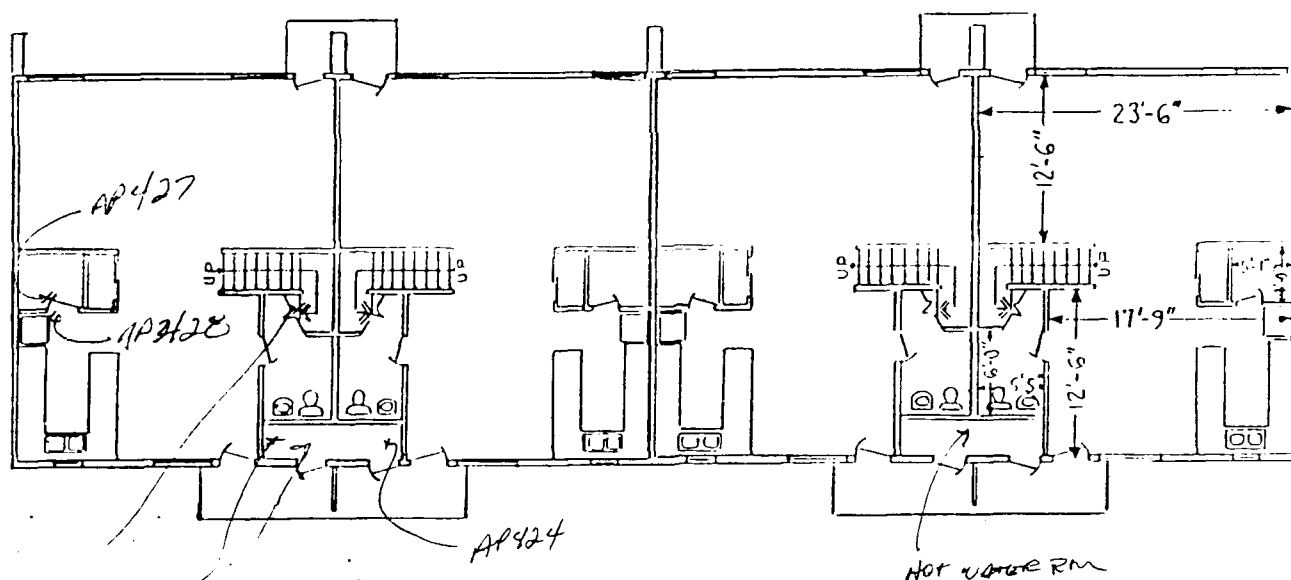
59 NAVY DRIVE

This is a two 3 bedroom, 2 bath home with tan aluminum siding. There are no floor vents present. The furnace room has residual air cell type insulation in the foundation. There are 3 types of floor tile present. There is spray on (white decorative type) in all the rooms. The roofing shingles and felt are suspect. This is a type C, 3 bedroom town home. It was chosen because it is vacant and based upon available drawings, maintenance records, and discussions with maintenance personnel. This is one of three types of homes present. It is

the predominant type of home.

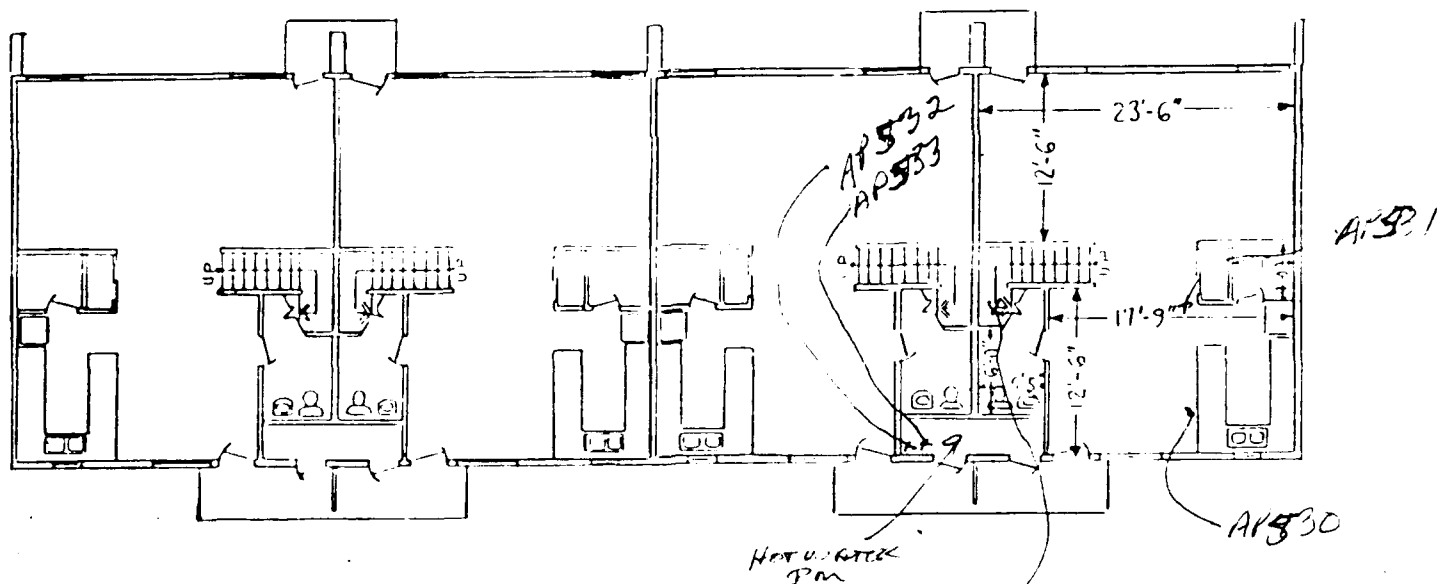
48 ANNIS DR.
DAVISVILLE, RI

NOTE NO.	NOTES/REMARKS/COMMENTS/DETAILS/OTHER MATERIALS, QUANTITY, ETC.
01	air cell type insulation coming up through foundation, but is cut flush. Less than 4" size
02	12x12 white with brown floor tile in 1st floor bath only
03	9x9 purple floor tile in living/dining and second floor bedrooms.
04	12x12 floral pattern floor tile in kitchen only.

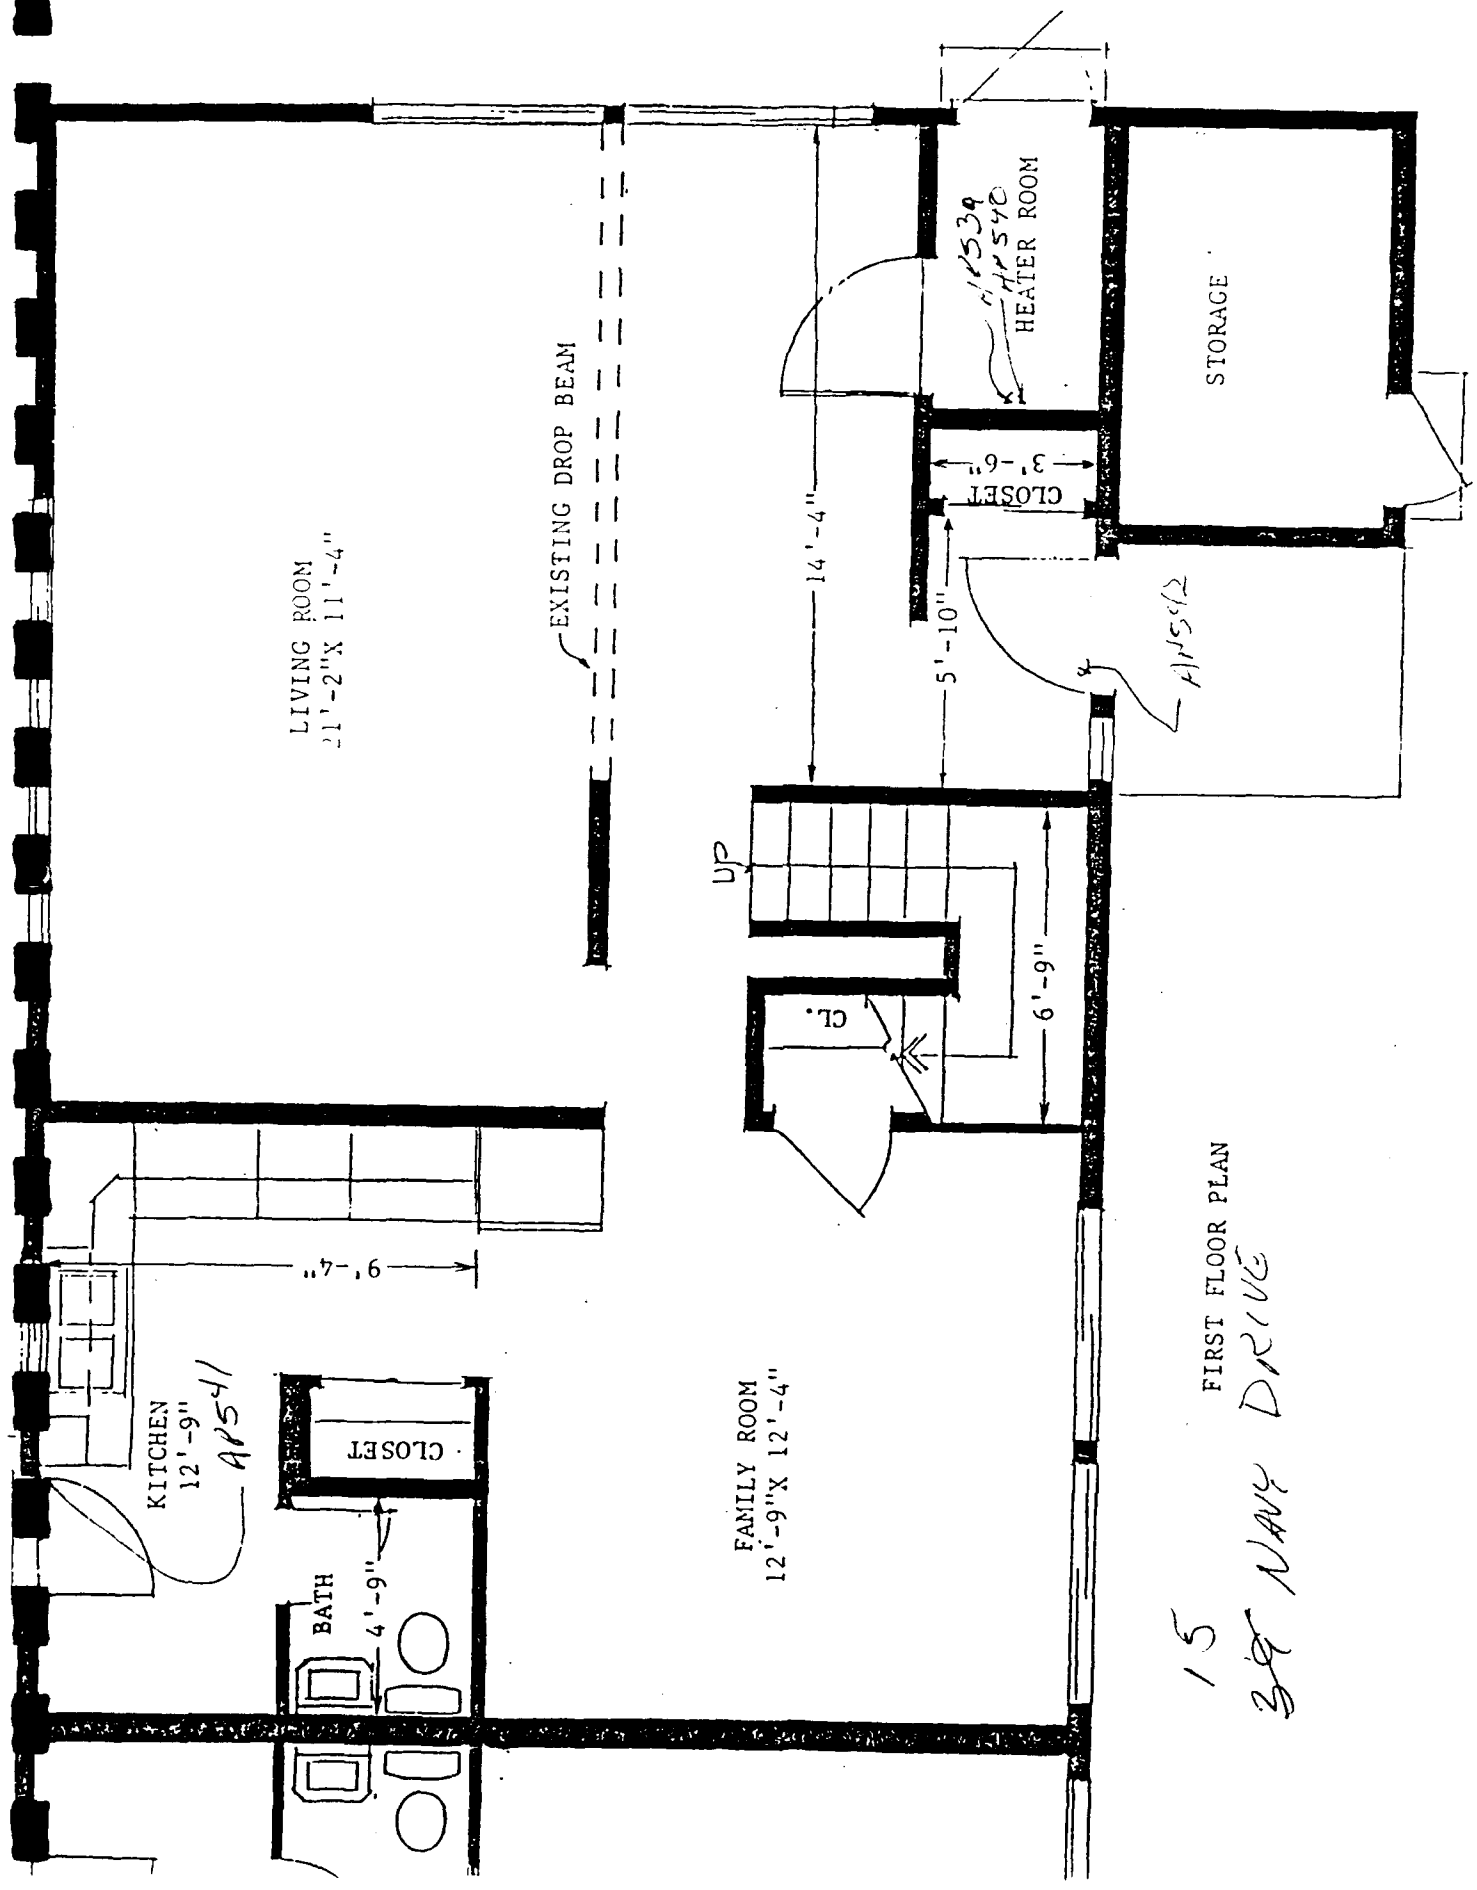
15
FIRST FLOOR PLAN
38 NAVY DRIVE

NOTE NO.	NOTES/REMARKS/COMMENTS/DETAILS/OTHER MATERIALS, QUANTITY, ETC.
01	air cell type insulation that comes up through foundation, but is cut flush with foundation. Less than 4" size.
02	12x12 floral pattern floor tile in kitchen + 1 st floor bath.
03	9x9 purple floor tile in all rooms except 1 st floor bath and kitchen.
